Inspection & Receipt Details

210 Sunny Trail. Columbus, IN 47203

Accurate Home Inspections

Report Overview

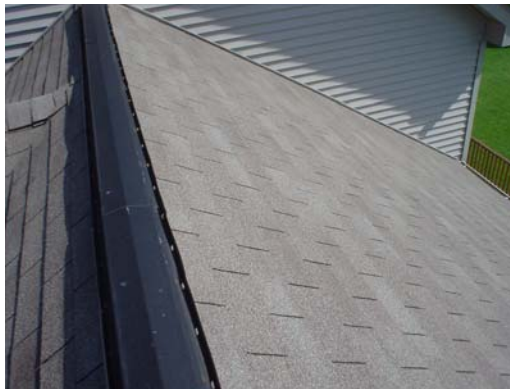
Roof View

- **Repair:** Minor repairs to the roofing are needed. Damaged or missing roofing material should be repaired. All roof penetrations should be examined and sealed as necessary.
- **Repair:** Roofing nails are lifting up the shingles. Recommend having a roofer hammer the nails down.

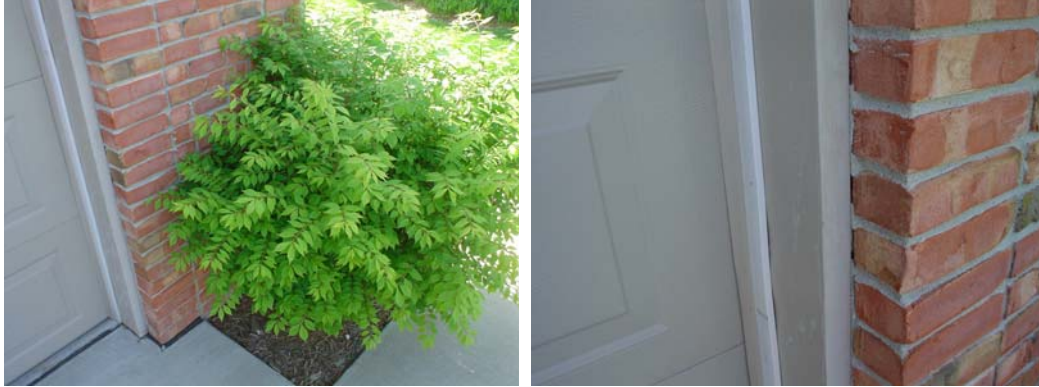
- **Improve:** Recommend caulking around the dryer vent and around the doors and windows.

Improve: Recommend keeping trees, bushes and shrubs trimmed back at least a foot away from the house to allow ventilation and to keep the siding dryer.

Trim Bushes - Caulk around door

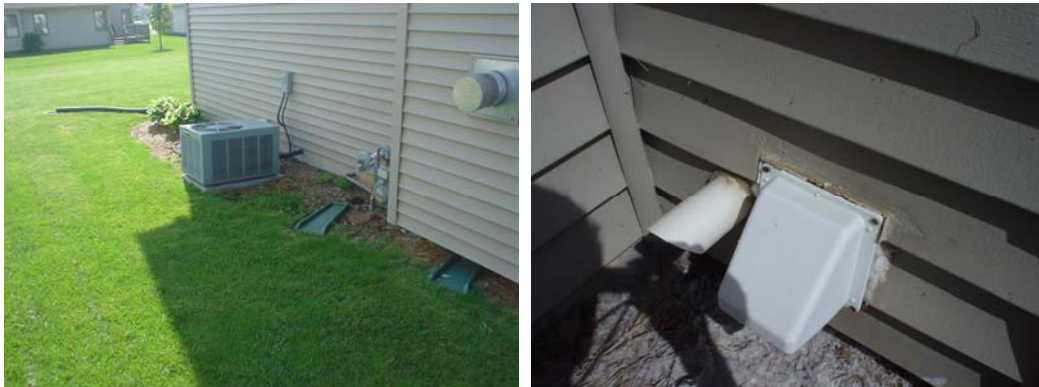
- **Improve:** The grading at the north side of the home should be improved to promote the flow of storm water away from the house. This can often be accomplished by the addition of top soil. The ground should slope away from the house at a rate of one inch per foot for at least the first ten feet. At least eight (8) inches of clearance should be maintained between soil level and the bottom of exterior wall siding.

Negative grade - Caulk around dryer vent

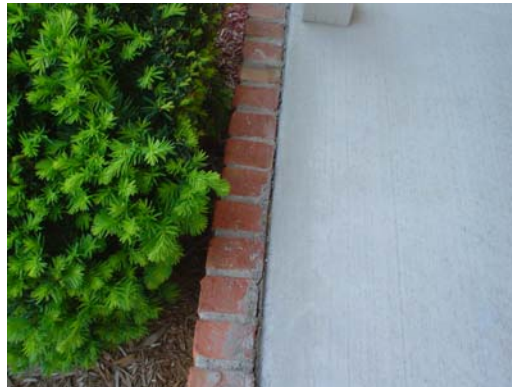
- **Monitor:** The bricks of the front edge of the front porch have a settling crack. Recommend caulking the crack to help prevent moisture damage.

Porch edge cracked

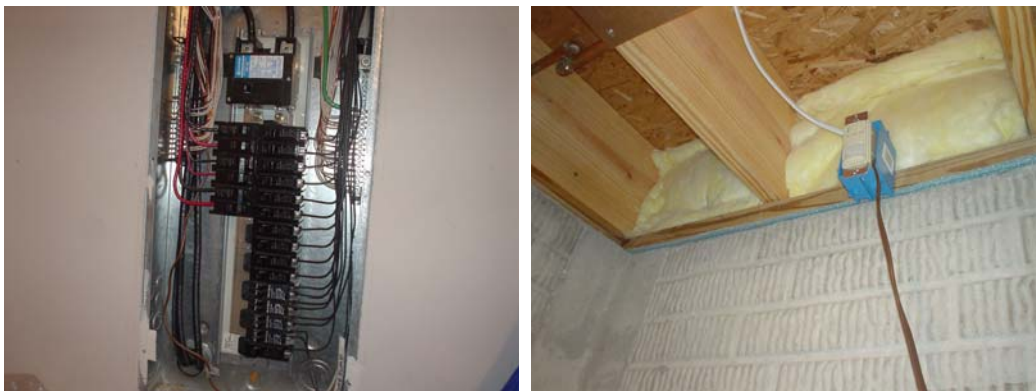
- **Repair:** Extension cords in the basement should not be used as permanent wiring. This wiring should be removed.

Main Panel View - Extension cord wiring
